**SKYLINE LAKE**

**DAM NO.1**

**NJ00203**

**PHASE 1 INSPECTION REPORT  
NATIONAL DAM SAFETY PROGRAM**

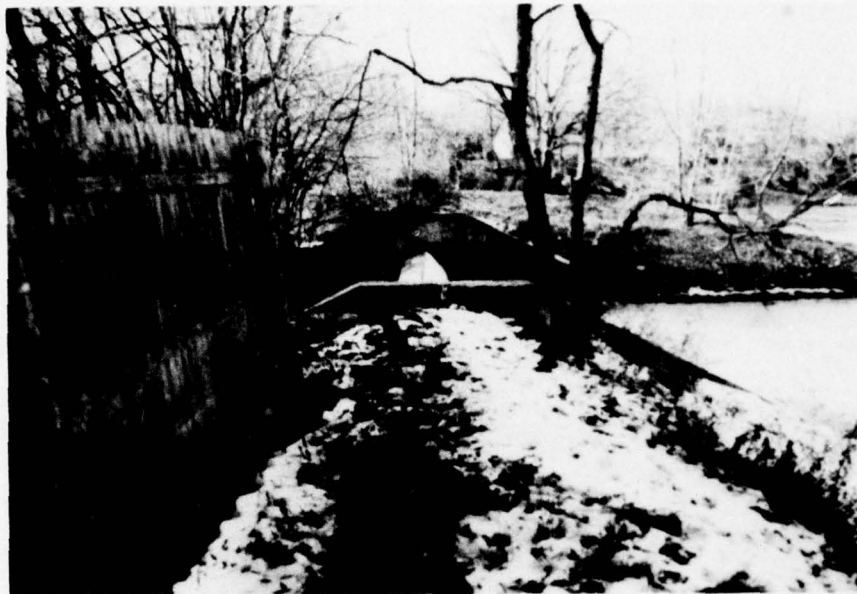
The embankment is partly covered with grass, brush and a few trees up to 1-foot in diameter. A residential property fence extends over part of the east embankment and snow was partly obscuring the upstream face of the dam at the time of the inspection (Photo 1). No riprap was observed on the upstream face of the dam.

Photo 1 View along dam crest looking west

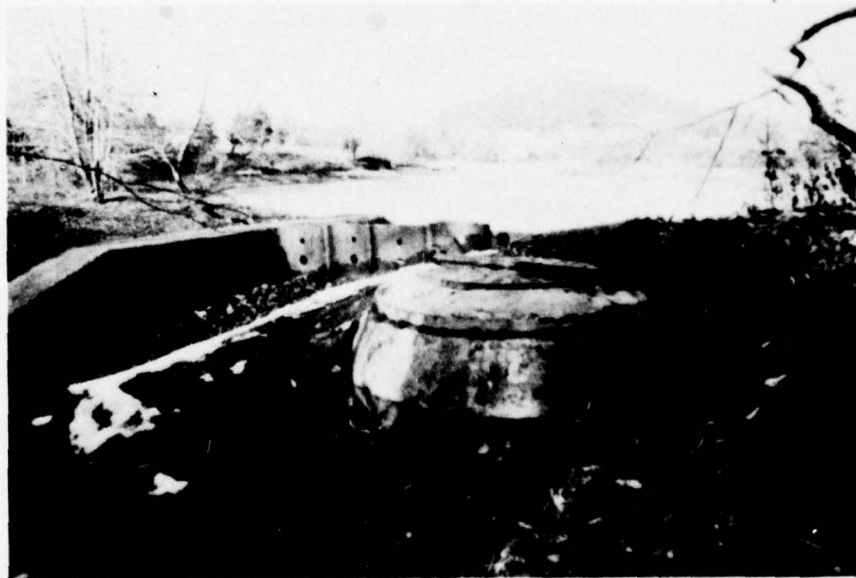
Erosion of the embankment, to a maximum depth of 1 foot, adjacent to the spillway walls was observed. The steel sheet pile core wall was partly exposed due to this erosion (Photo 2). An erosion scar approximately 2 feet deep and 4 feet wide was noted at the downstream side of the east embankment abutment (right hand side of Photo 3).

Photo 2 View of left (east) spillway abutment looking upstream

(4) Repair eroded areas of the embankment adjacent to the spillway wing walls.

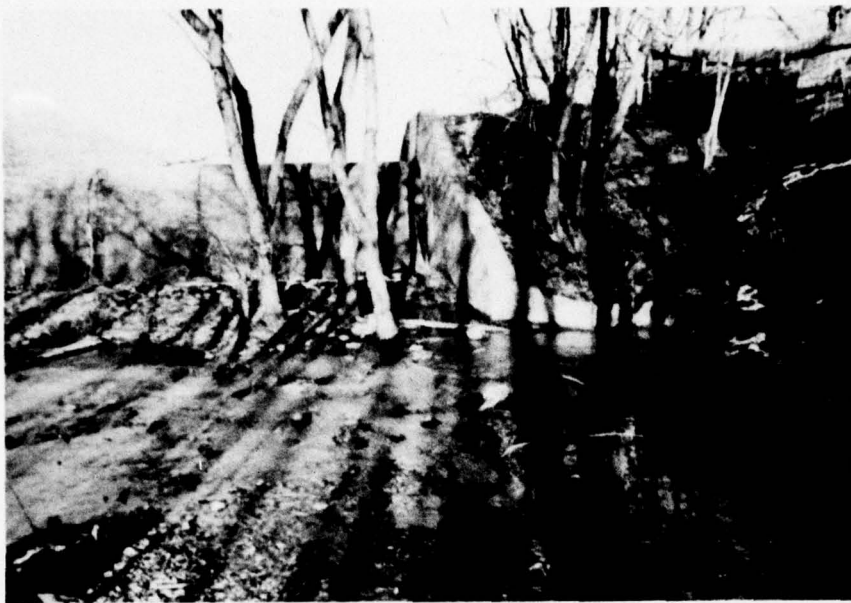
The intake to the outlet pipe was submerged during the inspections and therefore could not be observed. During the December 1, 1978 inspection the water level downstream of the dam was about 1 foot above the invert of the outlet pipe and water was discharging from the outlet pipe at an estimated rate of 100 to 150 gpm during the inspection (Photo 3).

Photo 3 View of left abutment looking upstream

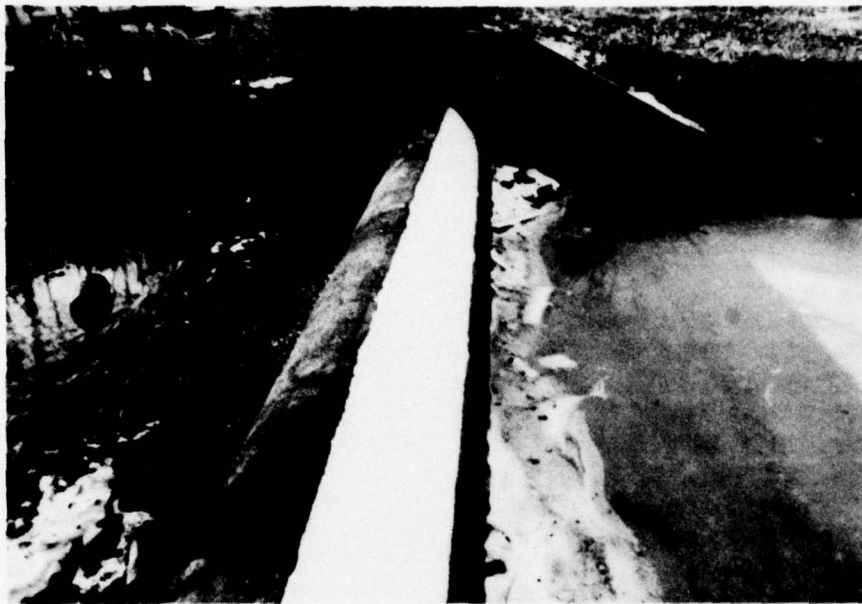
Photo 5 View of spillway crest looking west

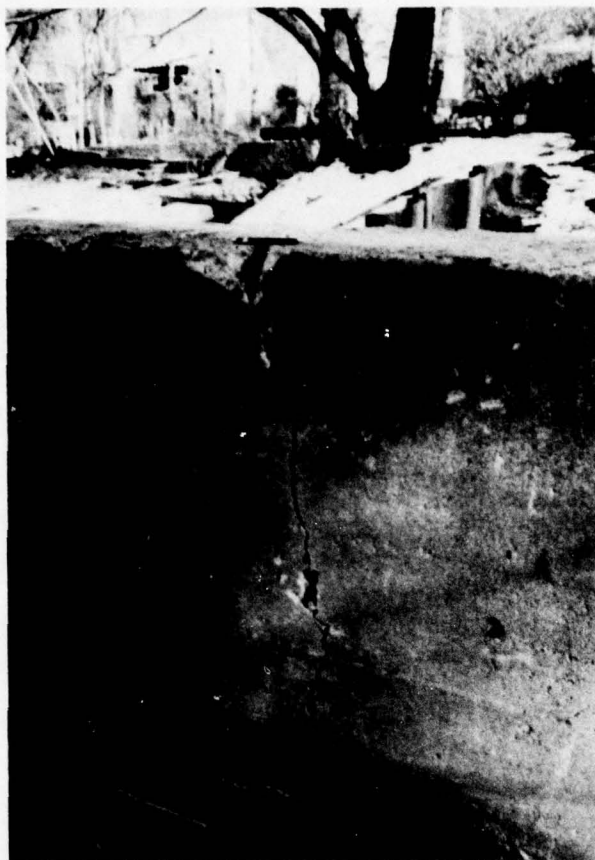
There are vertical cracks in the centers of both concrete wingwalls extending from the top of the walls to the top of the spillway crest (Photo 7). Both cracks are open approximately 1/4 inch and spalling has occurred along the crack in the left (east) wingwall.

Photo 7 View showing  
crack in left (east) wing  
wall

(3) Repair the cracked and spalled concrete spillway wing walls.
